Pakistan, Gilgit - Baltistan

Attabad Landslide Dam – Risk Management Suggestions

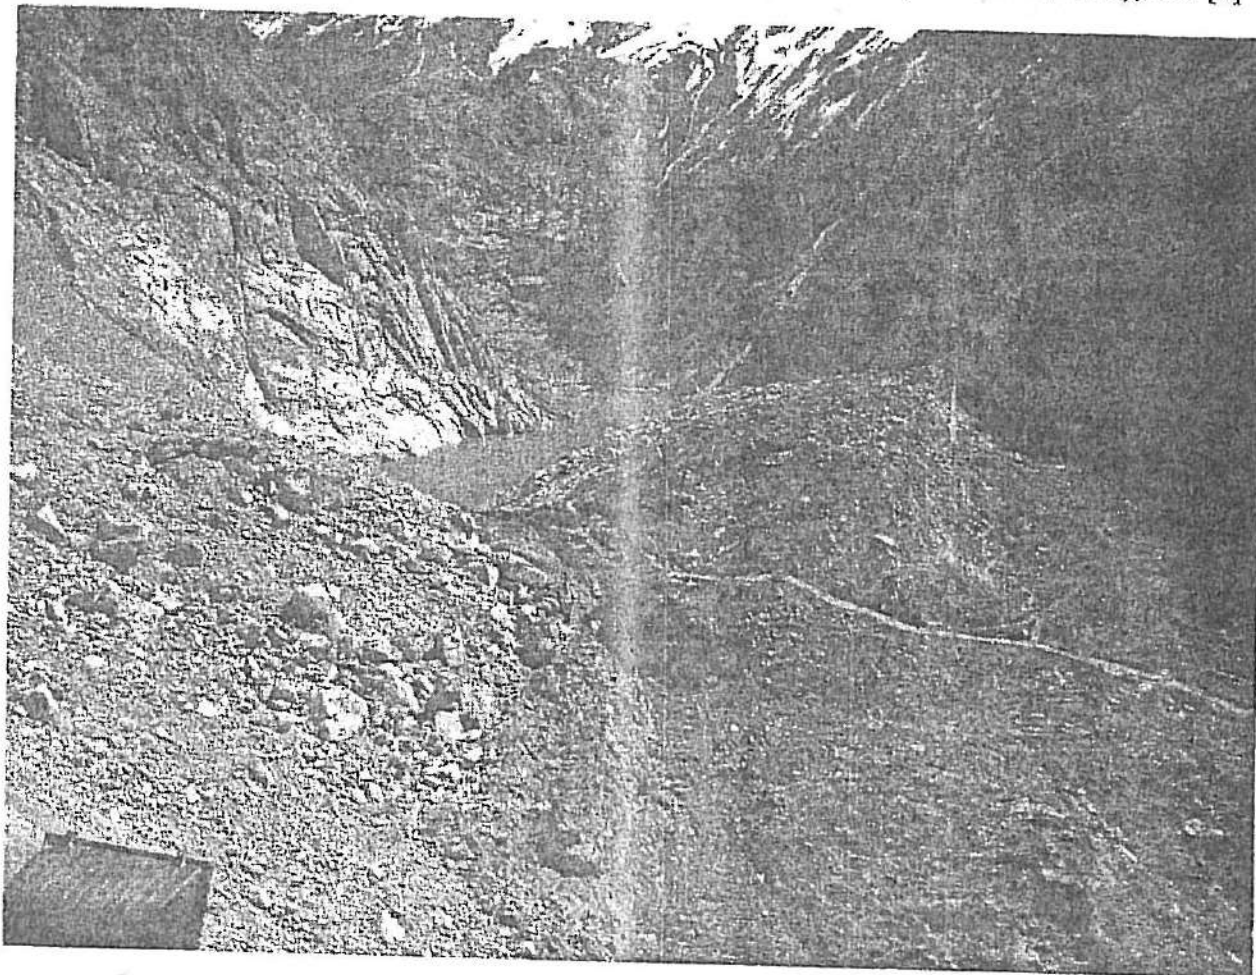
View of the Dam from the Observation Point on the Right Bank (March 15, 2010), ref. [2]

The emplaced landslide mass consists of a c.140 m high (at the saddle – the lowest point) rock and debris deposit, blocking the valley for a distance of over a kilometer. The main part of the landslide dam is a colluvial material consisting of a fine, sandy matrix with isolated clasts (rock blocks) of granite and granodiorite. The clasts are generally angular, ranging in size from a few centimeters to >10 meters. The deposit is matrix supported (i.e. the blocks are mostly not in contact with each other, probably deriving primarily from a pre-existing colluvial deposit on the hillside at Attabad. On the upstream side of the dam on the south side of the landslide there is a large rockslide deposit formed primarily of large and very large boulders, with little or no matrix support. This deposit appears to represent a late stage collapse of a large block of bedrock. The saddle of the landslide and the downstream face is mantled with a thick layer of the lacustrine deposit, consisting primarily of clay- and silt-sized particles, with some rounded fluvially-transported pebbles and cobbles. This material has a very low plasticity index and appears to have low permeability. The surface of the material appears to dry readily to leave a reasonably thin but strong surface layer, underlain by material with a high water content. This material behaves in an unusual manner, deforming readily when loaded without the surface layer breaking. This is proving to be problematic for the plant at the site, which breaks through the crust and becomes bogged down in the wet materials beneath.

The morphology of the landslide deposit is not unusual. The main landslide mass has banked up on the far (south) side of the valley, leaving a saddle on the near (north) side. The upstream face of the landslide mass is reasonably steep, but with no signs of significant instability. The downstream face is less steep as it is mantled along its whole length by the mudflow deposit. Three distinct mudflow channels are evident, although the mudflow deposit covers the entire downstream slope. Compression ridges are evident in this material, as are pools of water on the lower slope. Staining on the rockwalls show that during the passage of the mudflow the landslide was c. 5 m thicker than at present, indicating high mobility when saturated.

day. The freeboard is currently c.60 m. The dam appears to be essentially stable under current conditions, with only minor seepage on the downstream face, primarily associated with drainage of the mudflow deposit, and few signs of slope distress.
