REPORT FOR NATIONAL DISASTER MANAGEMENT AUTHORITY

CAUSATIVE MECHANISMS  
OF TERRAIN MOVEMENT IN HUNZA VALLEY

by  
S. HAMID HUSSAIN  
ADNAN ALAM AWAN  
ENVIRONMENTAL AND ENGINEERING GEOLOGY DIVISION

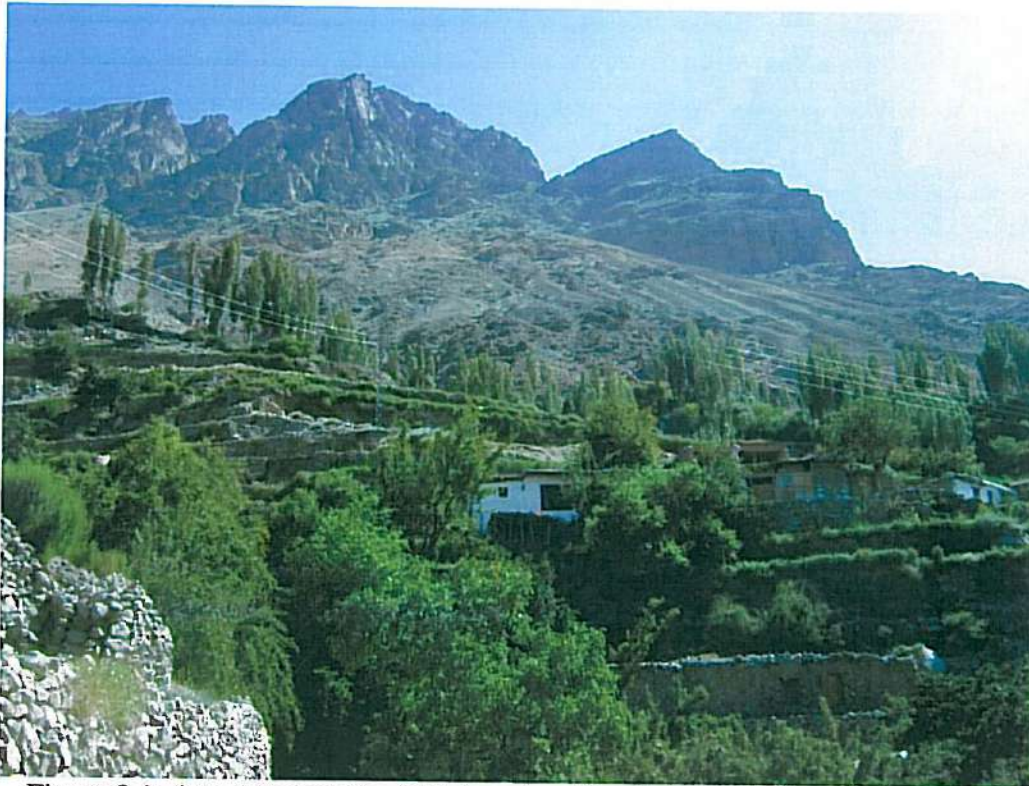
3. High slope angle is a major triggering factor for eastern Atta Abad (Fig 3.1). Slope angle at terraces is ranging from  $30^{\circ}$  to  $40^{\circ}$ , at backslopes from  $35^{\circ}$  to  $55^{\circ}$  and toe of terraces is near to vertical.

Figure 3.1: Atta Abad at direct hit from boulders lying at high angle backslope

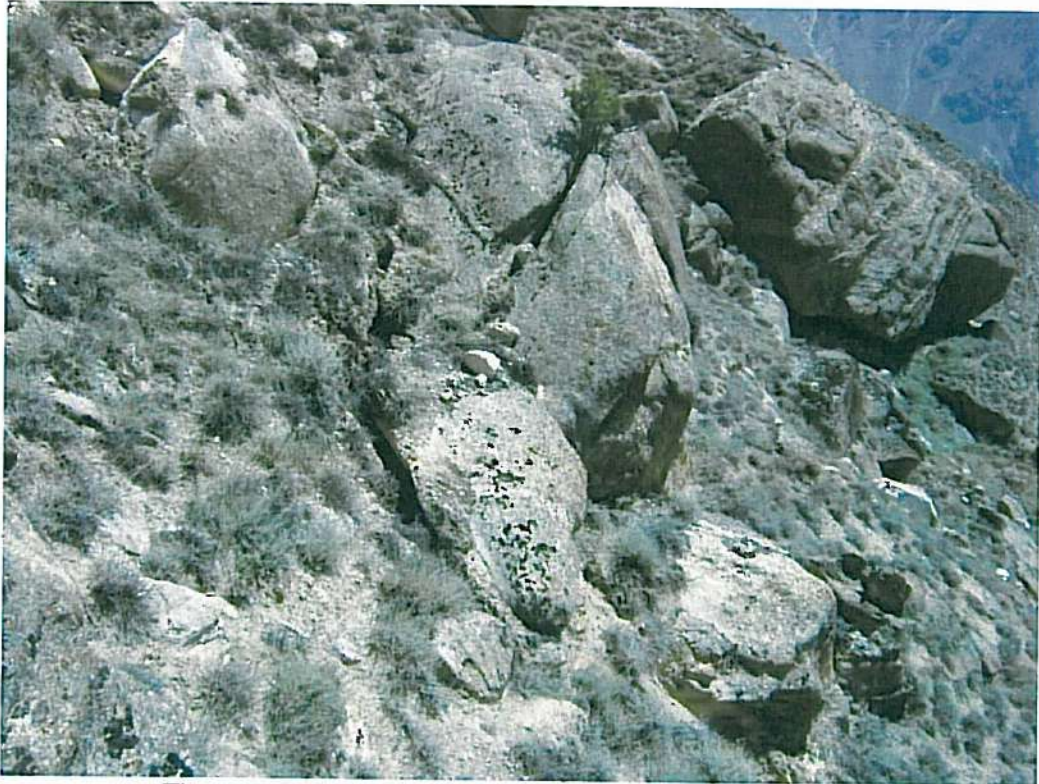
Figure 3.2: Huge boulders loosely lying on the baskslope

2. The boulders loosely lying on the backslope (Fig 3.2) should be safely brought down using the techniques of control blasting.
3. Poor drainage in the terraces should be managed into proper drainage and water should be diverted from infiltrating into cracks and loose overburden.

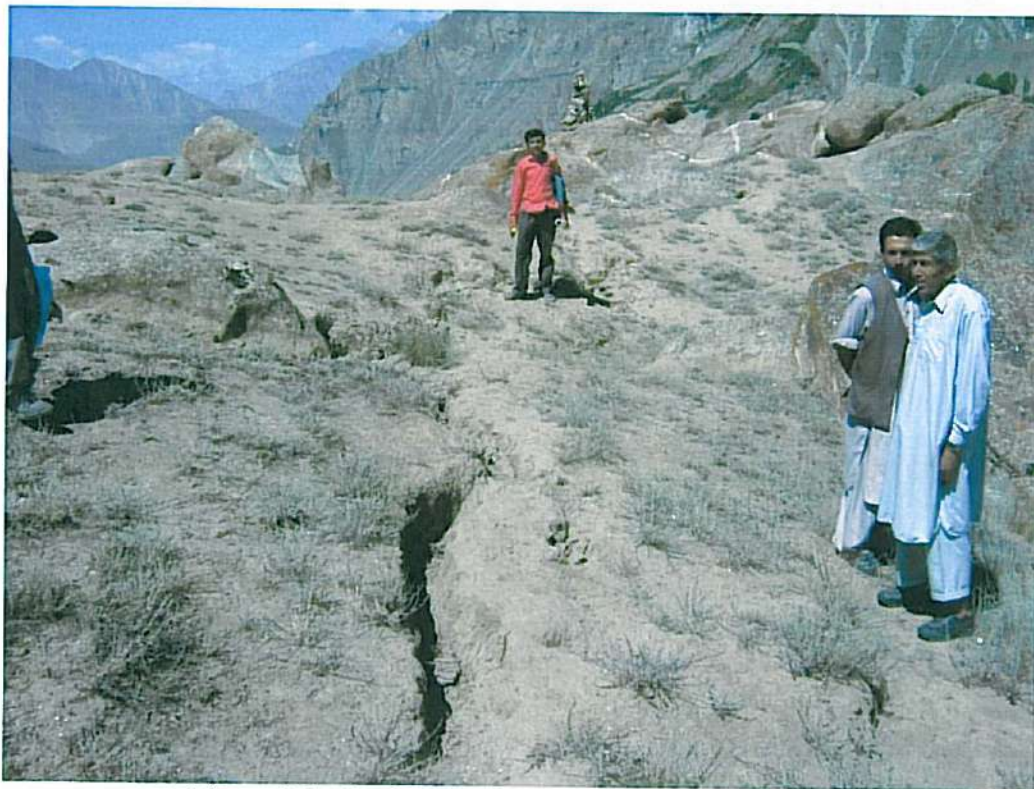
Figure 3.3: Crack widening at the left margin of upper slope

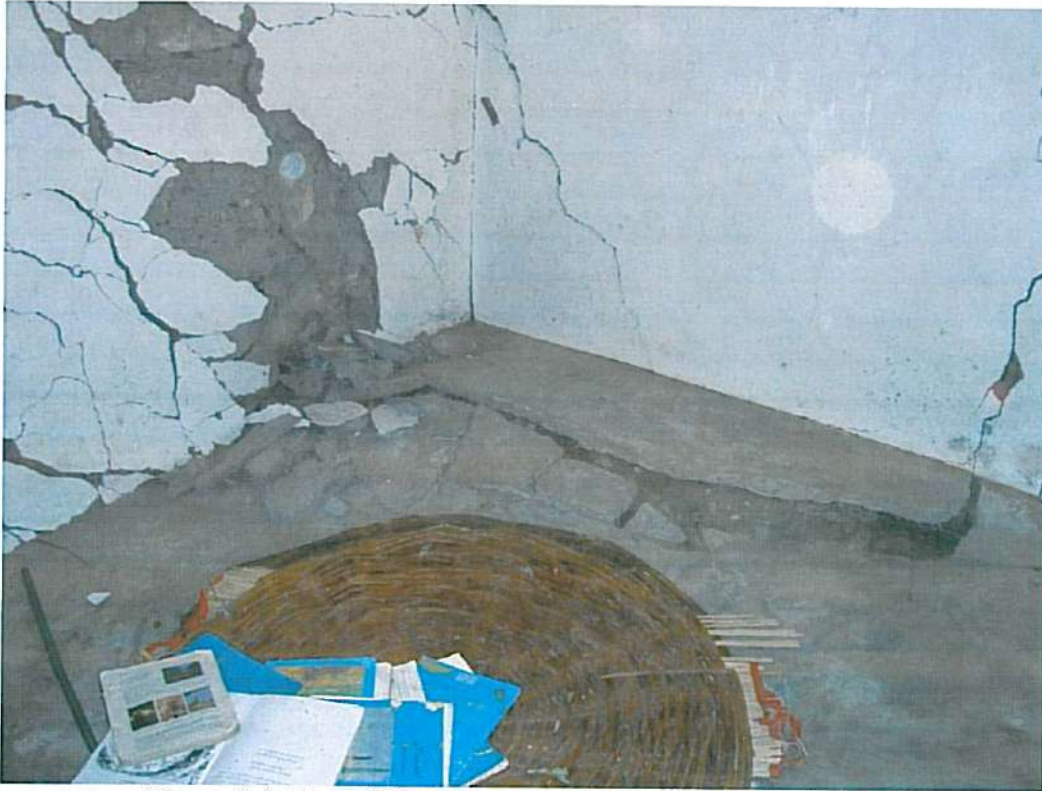
The network of cracks and fissures present in the area are the potential source of any future calamity and may result into loss of life and property. Three major networks of cracks (Fig 4.1) have been identified on the backslopes and one pattern of cracks has been observed at the terraces (Fig 3.4).

Figure 3.4: Slope failure at terraces have damaged the house

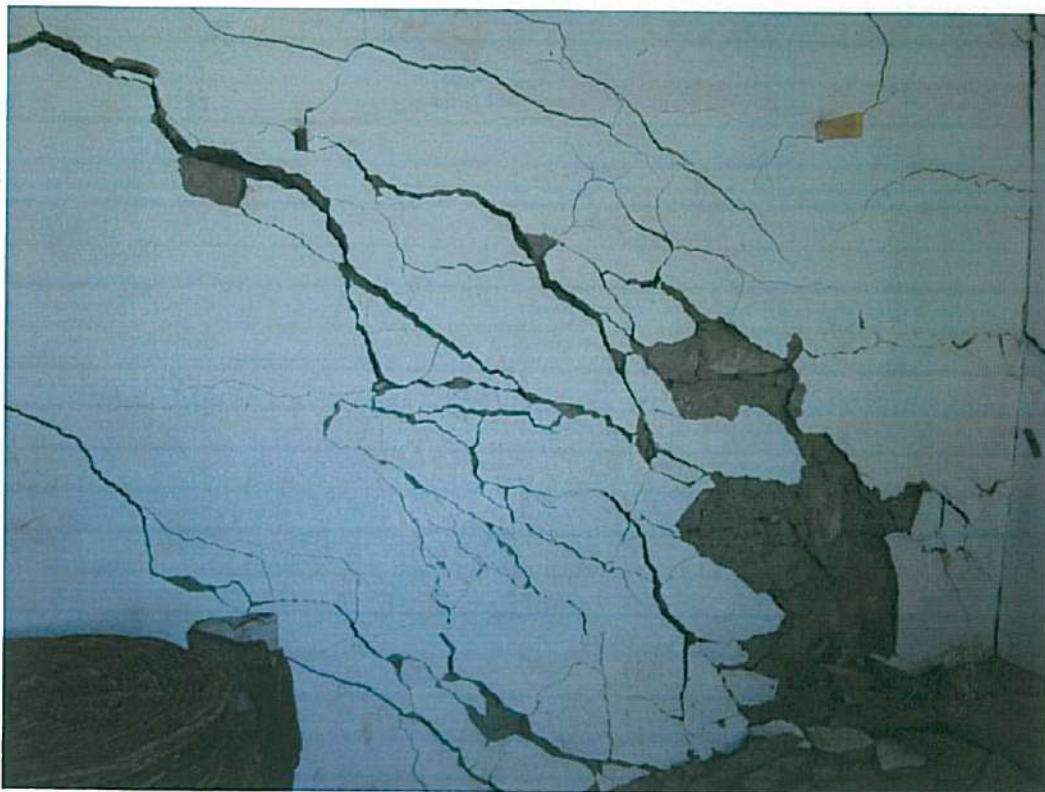
Figure 3.5: House damaged due to cracks on terraces

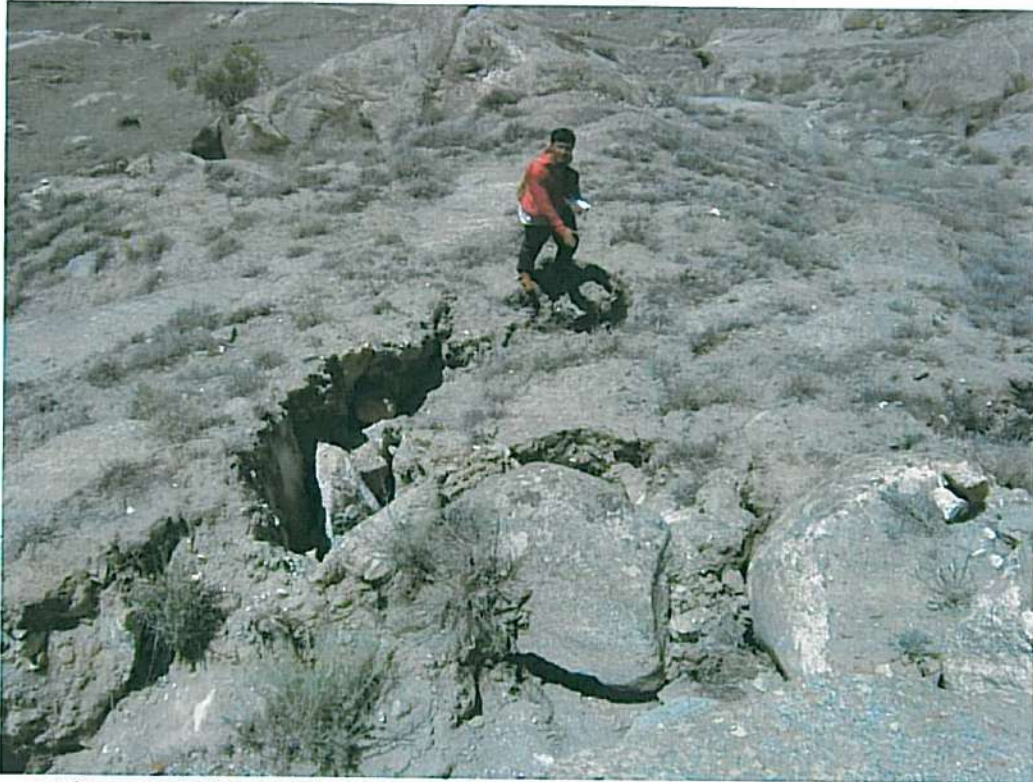
Figure 3.6: Very wide cracks posing a potential risk for Atta Abad village

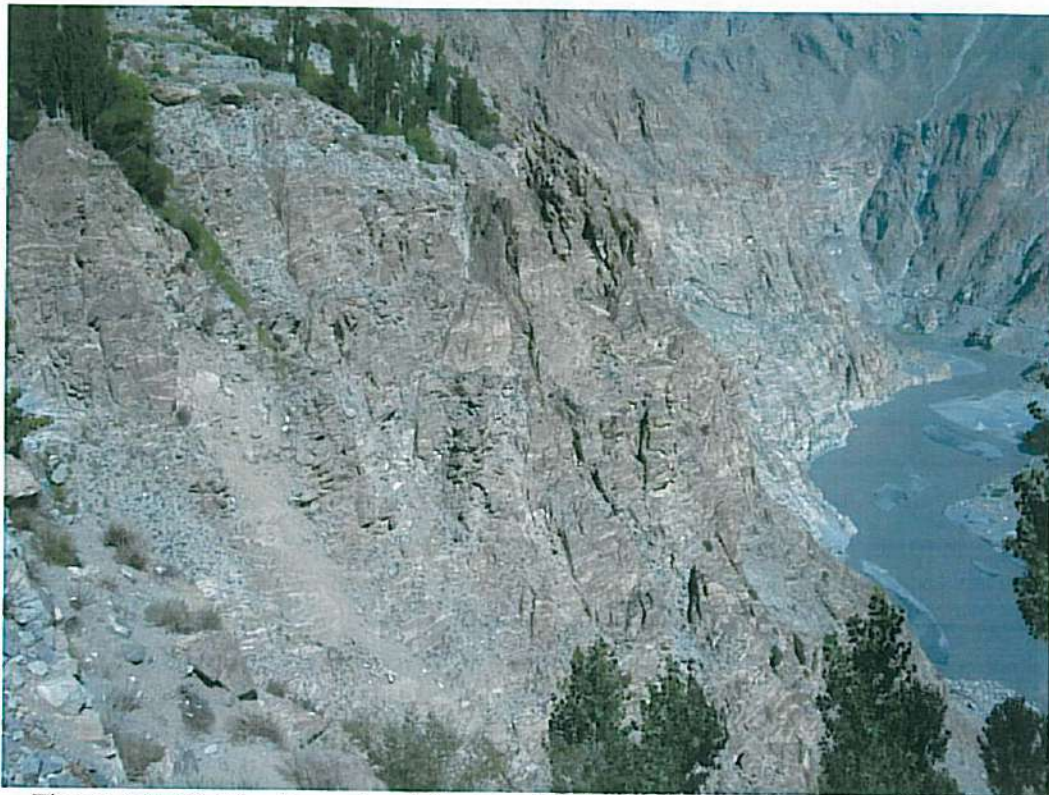
Figure 3.7: Highly sheared and fractured bedrock forming the toe of Atta Abad

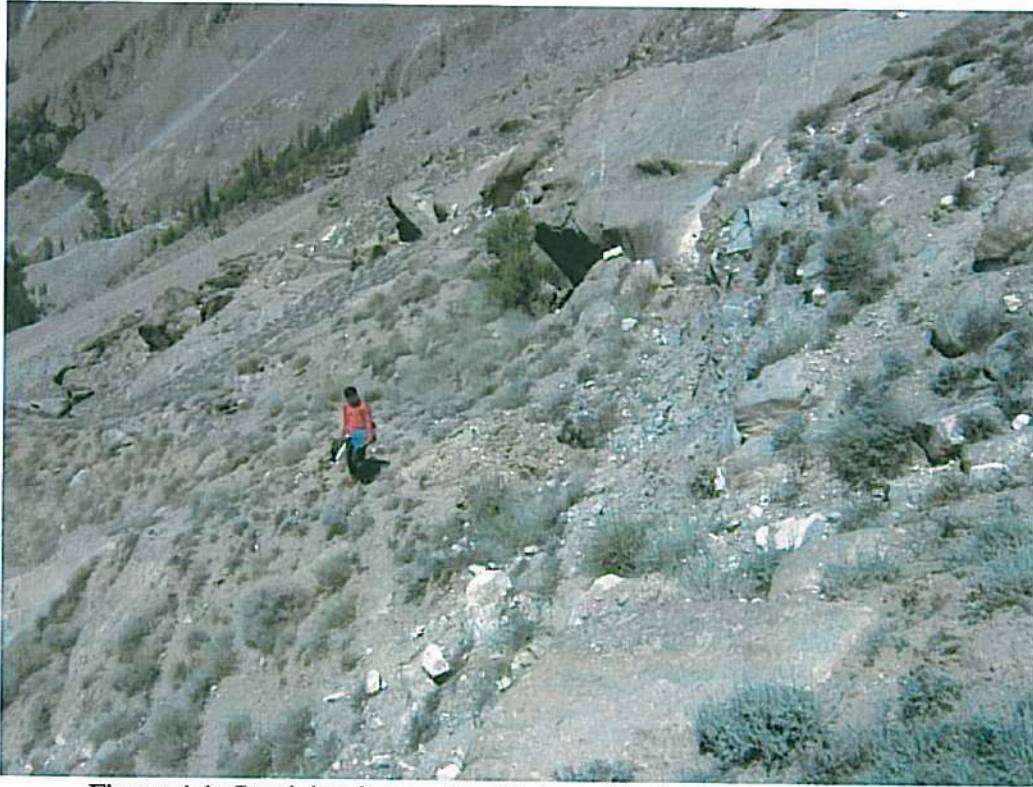
The area is at threat from multi directions. On one side huge boulders of room size (12x16x22 ft) are lying loosely at the backslops (Fig 4.1) and most of them have moved from their original location because of the slope condition, any movement in the slope or an earthquake of magnitude of 4.5 or greater on Ritcher Scale may roll down the boulders and hit the population. The toe of terraces is creeping and displacements of terraces are the result of this weak toe because the rocks are highly sheared, fractured and jointed (Fig 3.7). This part has a potential to slide down in the form of a rock avalanche and block the river. During investigation geological evidence of same kind of threatened river blockage has been identified at 1.2 km downstream at village Sarat (Fig 4.6). A landslide is present at the eastern margins of the area and material is falling into the river and it is further enhancing the triggering factors in the area (Fig 4.3).

Figure 4.1: Semicircular crack with large displacements at backslope

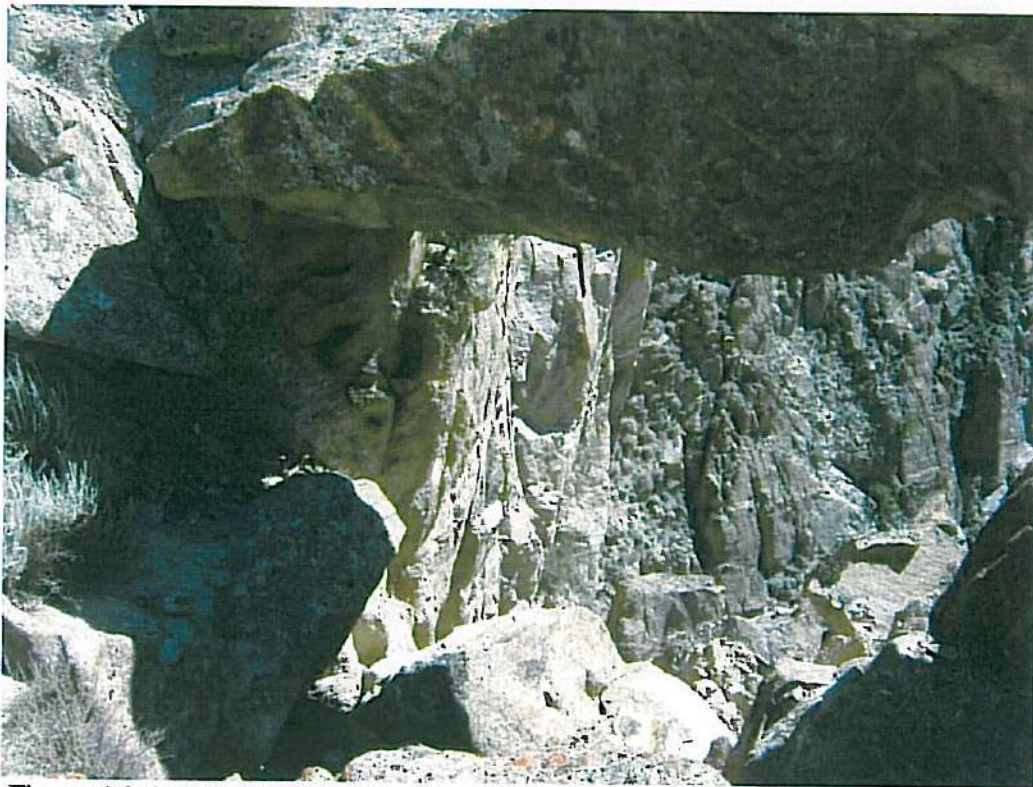
Figure 4.2: Boulder hanging dangerously on the widened crack at eastern margins

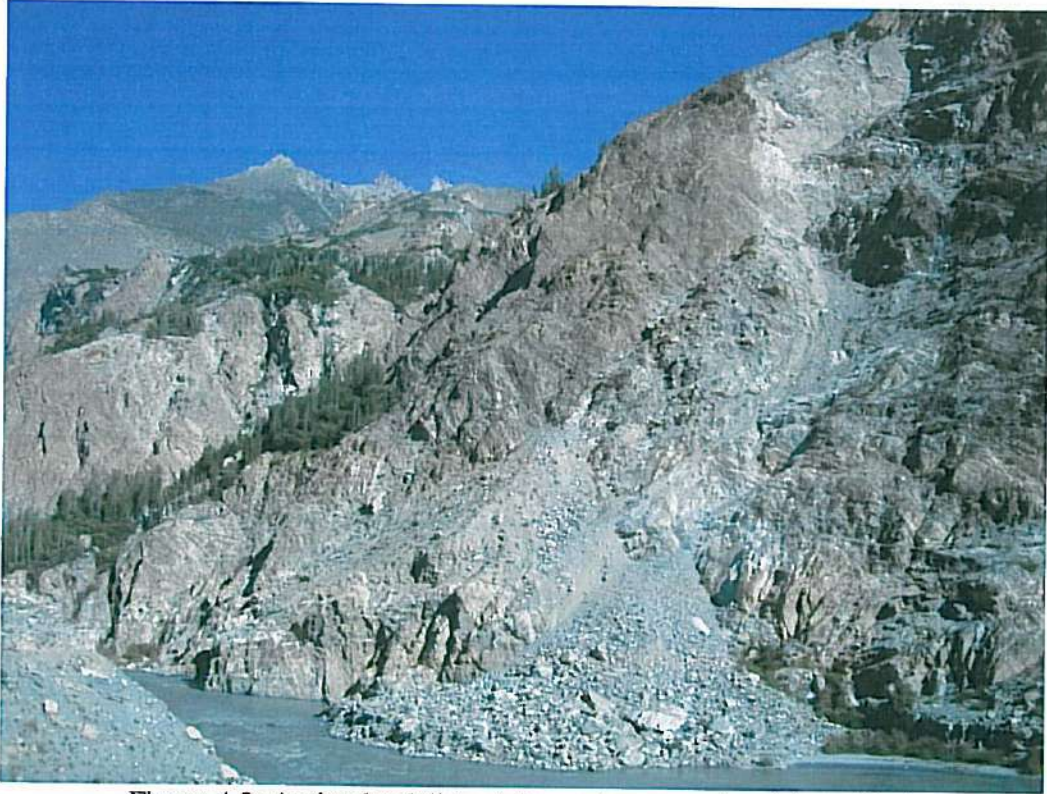
Figure 4.3: Active landslide at the eastern margin of Atta Abad

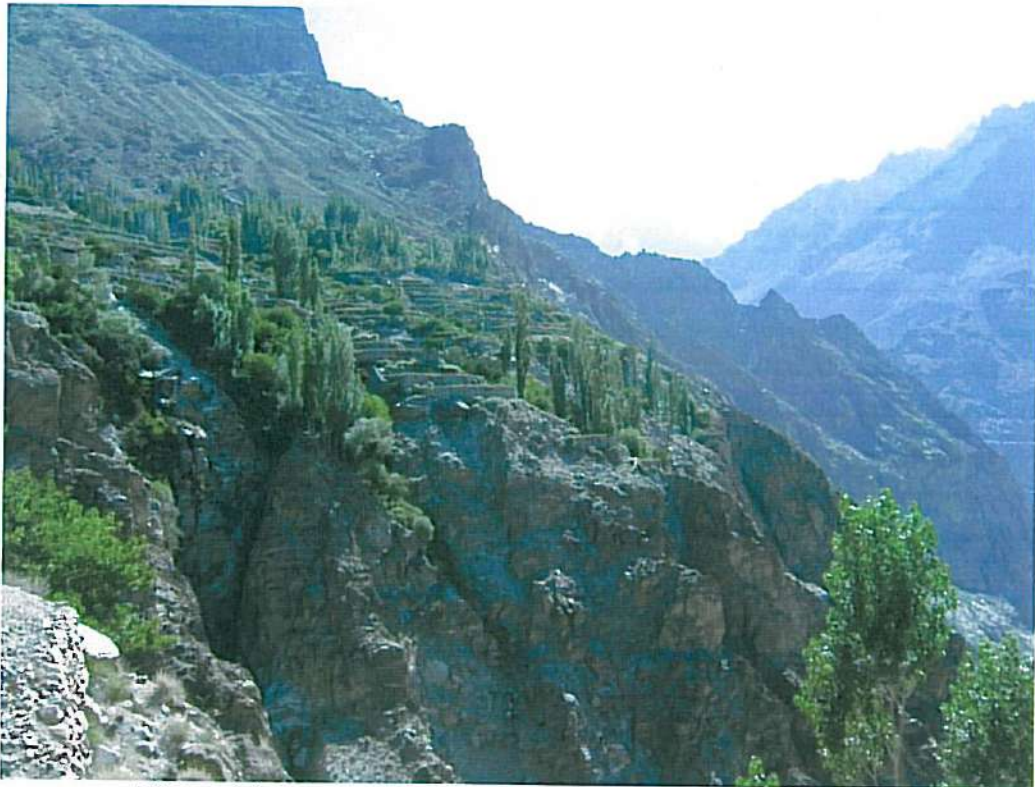
Figure 4.4: View of terraces, backslope and toe of Atta Abad village

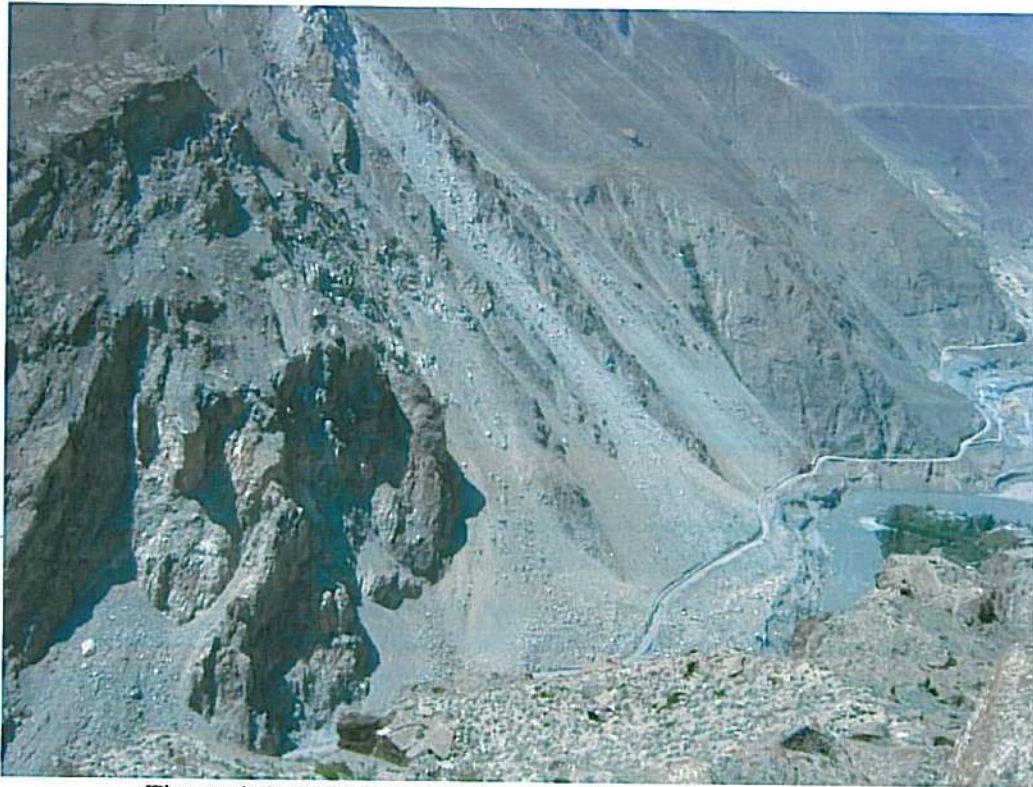
2. A fault is passing through the affected area having a strike NS and crossing the river. A huge landslide has developed across the river and timing of slope failure at Atta Abad and landslide across the river is quite same. This landslide is associated with the fault. The movement along this fault has weakened the shearing strength of the rocks and decreased the angle of repose in the area.

Figure 4.5: Active landslide across Hunza River, Atta Abad

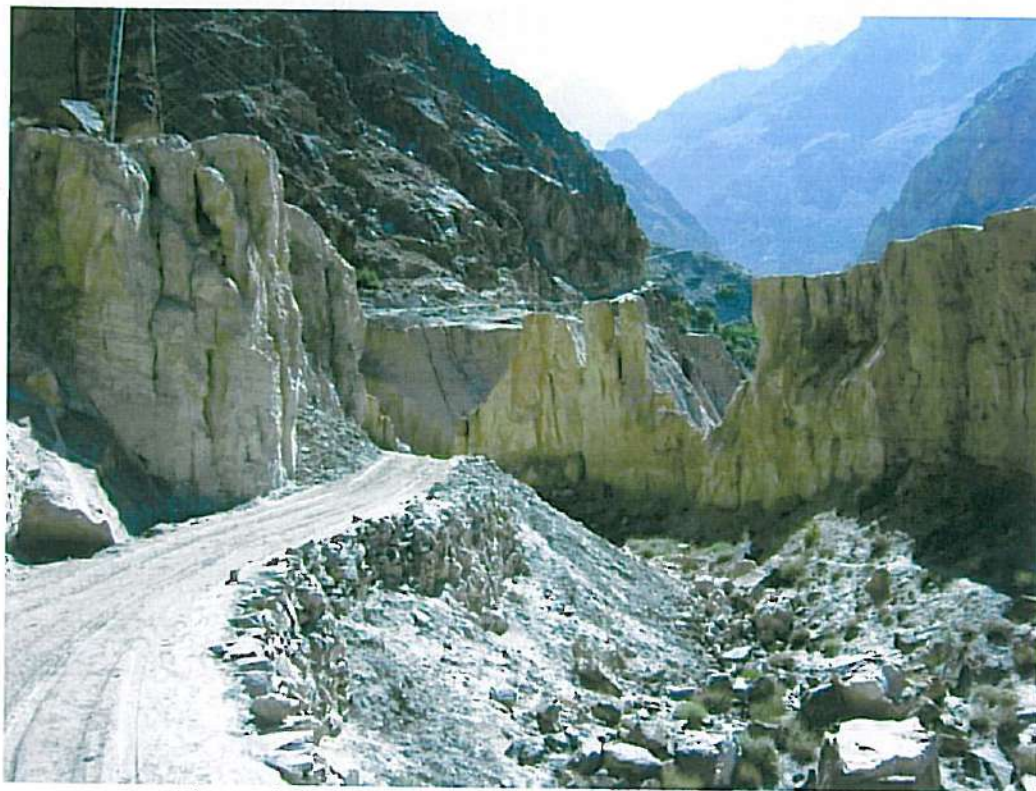
Figure 4.6: Lacustrine deposits near Atta Abad at village Sarat

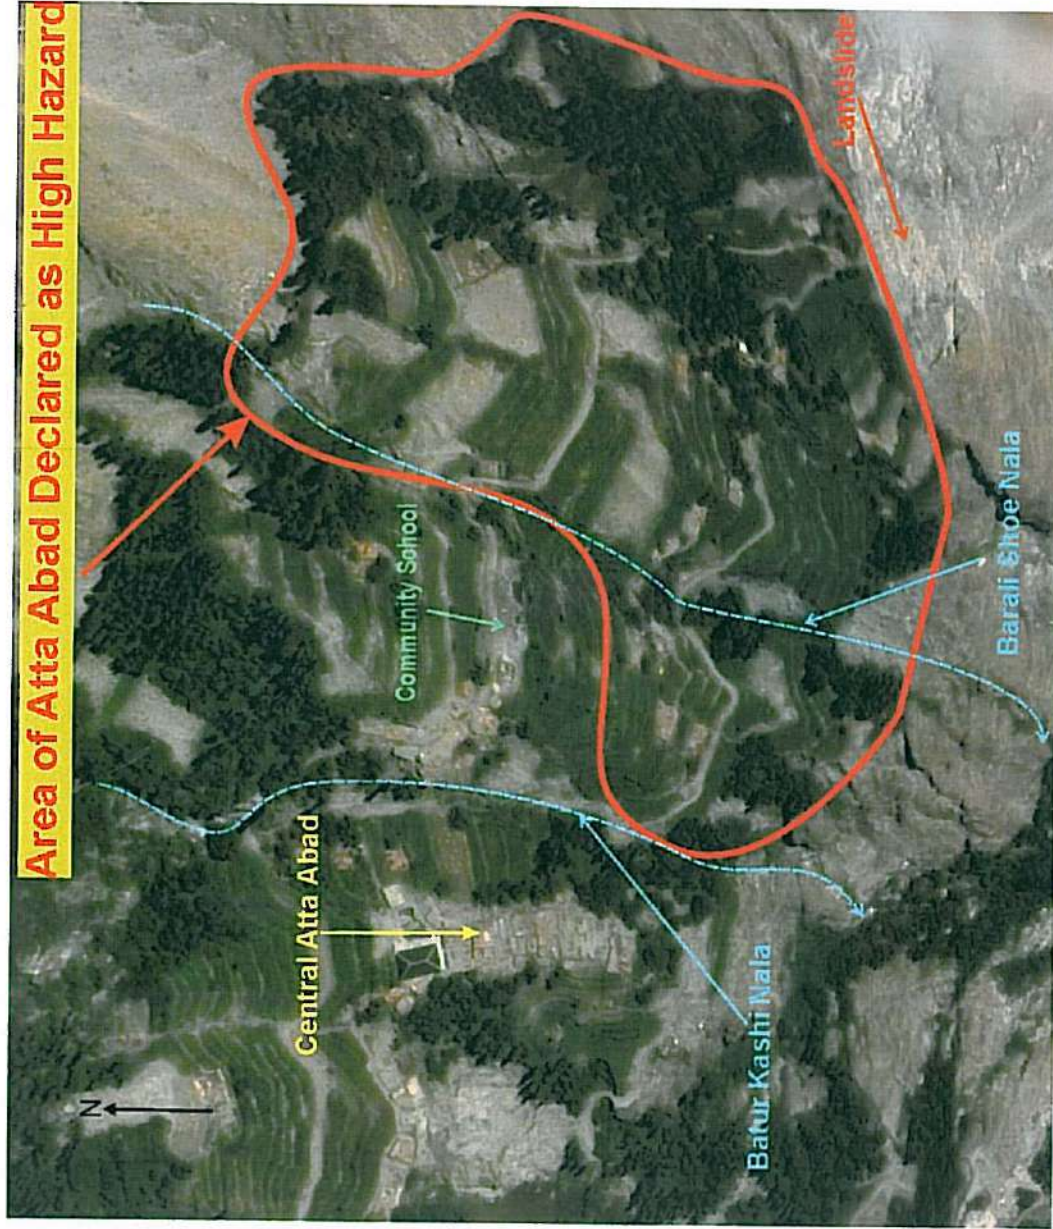
Based on the detailed Geological and Geotechnical survey carried out in the area, information collected from locals and authorities, the major portion of eastern part of Atta Abad is declared as High Hazard. The High Hazard area starts from the eastern most margins of Atta Abad and this area is locally known as part of Ghumrat. It is bounded by the half length (at coordinates 36 18 53.50 N & 74 48 55.30 E) of Barali Shoe Nala crossing the terraces. The line of High Hazard is extended parallel of the terraces to the Batur Kashi Nala and follows the Nala downslope. (Note: Boundaries of the High Hazard area demonstrated within the red line in Fig No.4.7).

Figure 4.7: Area of Atta Abad declared as High Hazard

1. The High Hazard area should be evacuated from the population immediately and the affected families should be compensated in the forms of alternate lands/others.
