**NATIONAL DISASTER
MANAGEMENT AUTHORITY**

INFRASTRUCTURE AUDIT GUIDELINES

FOR DISASTER RESILIENCE

**Infrastructure Advisory &
Project Development Wing**

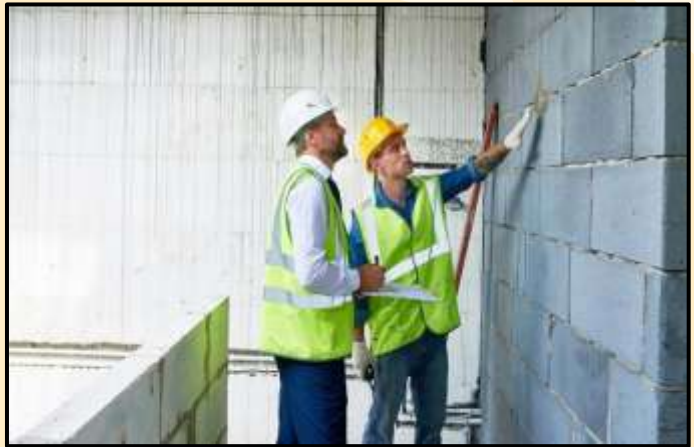
Figure 1: Visual Inspection of Building

Visual inspection is done by employing experience gained by the engineer and various research articles published in the field of structural auditing of a building, as illustrated in **Fig. 1**. The visual inspection process starts with the assessment of cracks, dampness, spalling over

the surface of any walls, columns, slab and all other structural and non-structural components of the building. It includes quantifying the moisture over the walls and other members.

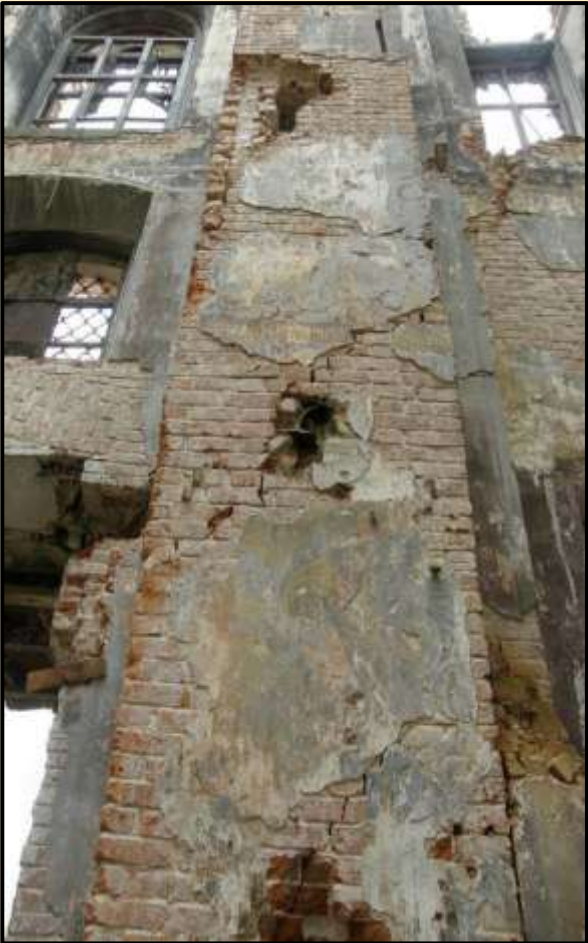
Figure 3: Deterioration of Old Age Building

Visual inspection also helps in assessing the condition of construction materials, such as concrete, steel, brick or timber, for signs of ageing, wear or chemical damage. This includes identifying corrosion, efflorescence, scaling or discoloration. Non-destructive tests, such as rebound hammer tests for concrete or ultrasonic testing for steel, can be employed to assess material strength. Environmental factors such as moisture, temperature fluctuations and exposure to chemicals should also be considered, as they may contribute to material degradation.

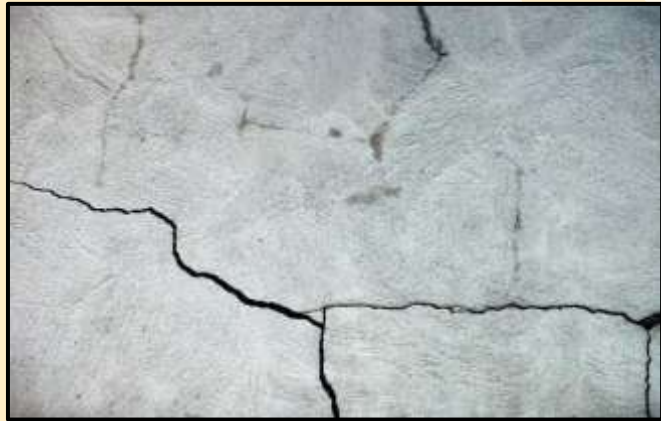
Figure 4: Cracking in a Wall

Auditing for cracking involves a detailed examination of all structural and non-structural elements, with attention to the cracks' size, pattern and location. These cracks are categorized based on their type, such as shrinkage, settlement or structural cracks,

which may indicate significant underlying issues. Tools such as crack width gauges are utilized for precise measurement. It is essential to determine whether cracks are active (progressive) or dormant and to analyze their potential impact on the structural integrity and serviceability of the building.

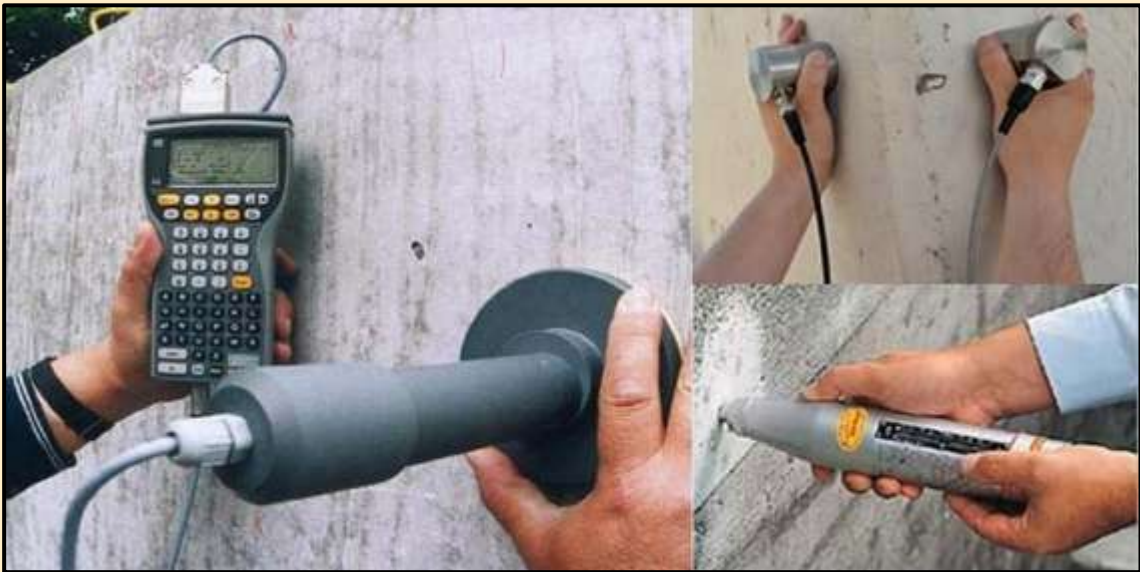
Figure 6: Non-Destructive Testing Methods

Non-destructive Testing detects quality without destructing the material or changing its properties. Estimating concrete strength, evaluating existing conditions and placement of rebars are crucial aspects of construction, as well as providing insights into the material's durability and structural integrity.

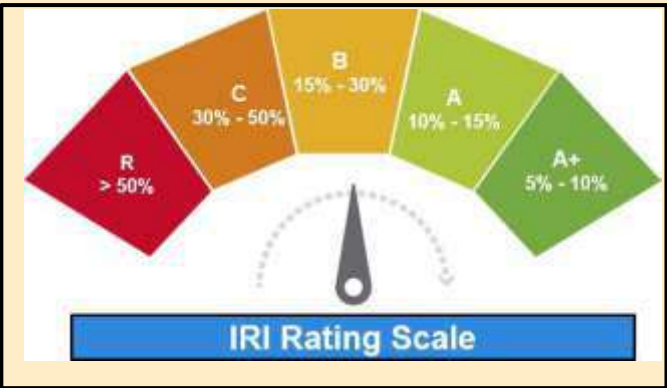
Figure 9: IRI Rating Scale

The IRI has adopted the World Bank’s 5-level rating scale, as depicted in **Fig. 9**. These levels are also described in the Table 3 shown below and explained in the following sections. The

categories show Probable Maximum Loss (PML), which the different category of buildings can face during a disaster.

Based on Probable Max Loss that can occur, the structures are divided into 5 categories as shown in Table 3. If the score from the checklist is below 190, the building will fall in category R, meaning the structure has a probable maximum loss capacity of greater than 50% and resilience less than 50%. This would require an in-depth understanding and assessment to recommend tailored retrofitting and strengthening.

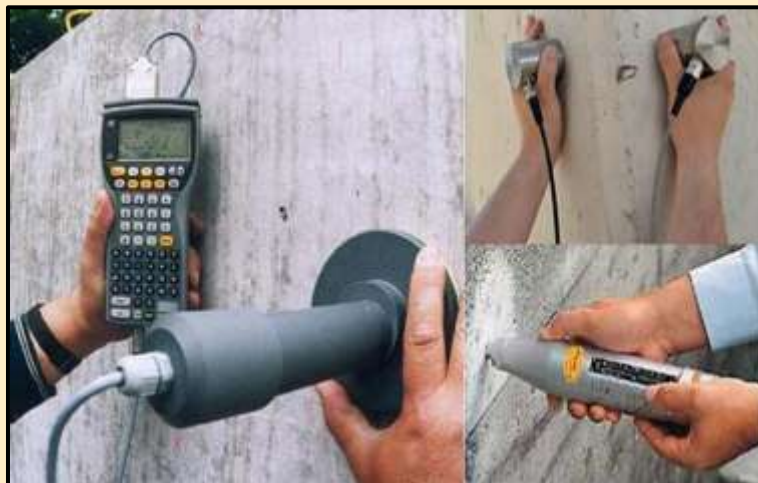
Figure 10: Non-Destructive Testing & Evaluation of the Requirements of Construction Standards

Schmidt's Hammer Test is based on the principle that the "rebound of a spring-loaded mass depends on the hardness of the concrete surface on which the hammer strikes." This rebound distance of the rebounded plunger mass is noted in the graduated scale as the rebound number/rebound index. The graph in the hammer's body is used to determine the respective compressive strength. The concrete with low energy and stiffness absorbs more energy from the plunger, producing a low rebound value on the scale. This is crucial in calculating the strength of concrete or brick.

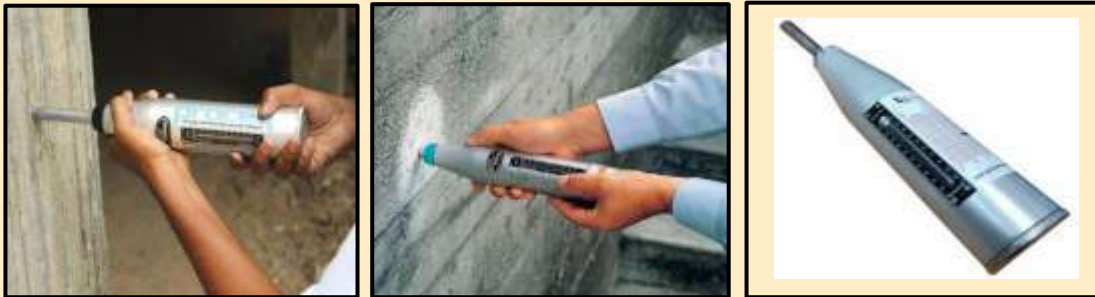
Figure 11: Apparatus of Schmidt Hammer

The process involves ensuring the surface is clean and free from loose particles or debris by NDT Professionals. Once calibrated, the rebound hammer is positioned perpendicular to the surface of the concrete structure to capture readings. The test can be performed horizontally on a vertical surface or vertically upwards or downwards on horizontal surfaces.

The rebound hammer is then placed against the concrete surface, releasing the hammer to measure the rebounded energy. Factors such as NDT Techniques for surface flaws, moisture content and reinforcing bars should be considered when interpreting the results.

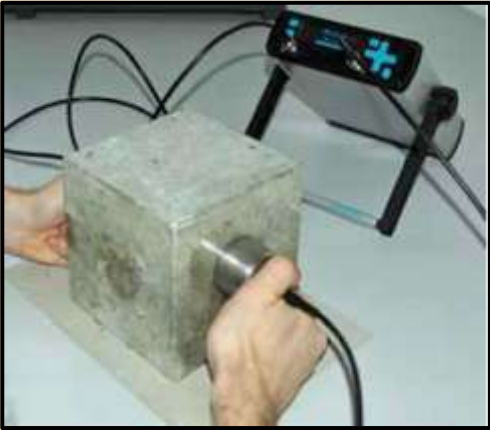
Figure 12: Apparatus of Ultrasonic Pulse Velocity Test

Ultrasonic Pulse Velocity (UPV) testing is a non-destructive technique widely employed in Civil Engineering to assess the integrity and quality of concrete structures. This method utilizes ultrasonic pulses to measure the speed of sound waves as they travel through a concrete specimen, providing valuable

information about the material's uniformity, homogeneity and potential presence of defects such as cracks in concrete. UPV testing is crucial for evaluating the concrete quality and homogeneity, detecting poor patches, internal flaws, cracks and honeycombing. Its non-invasive nature and ability to provide quick and reliable results make it an essential component of concrete quality control.

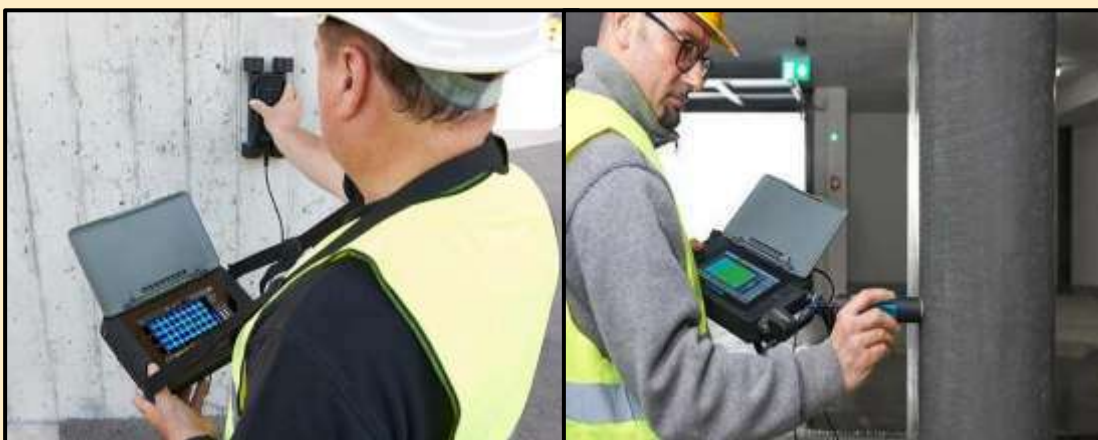
Figure 14: Profometer Test for Rebar Assessment and Corrosion Analysis

The profometer test is widely used and has many applications. For instance, it is used to specify reinforcement size, location and condition of existing structures to evaluate their actual strength and location reinforcement is necessary to be determined before drilling and cutting cores for testing concrete, analysis of corrosion, conformity check and quality assurance.

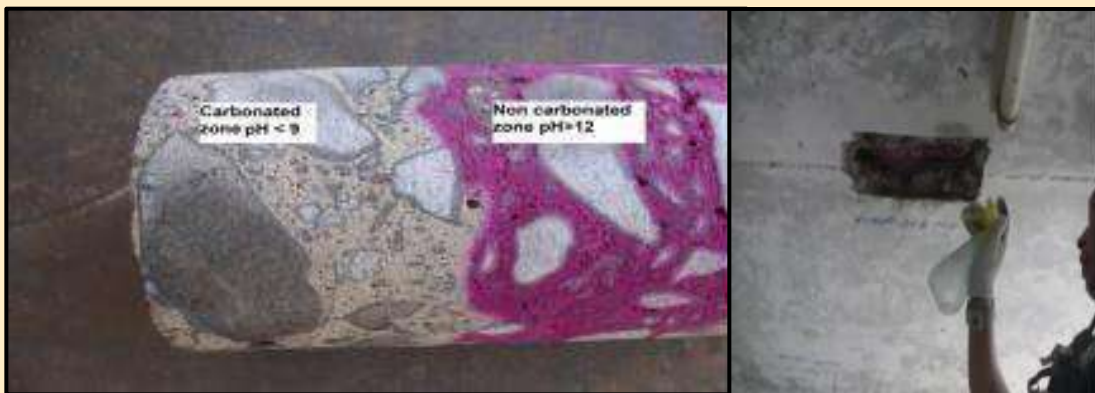
Figure 17: Carbonation Test on Concrete

One benefit of the carbonation test is that the results are immediate. Removing the sample and shipping it to a laboratory is unnecessary. All testing can be done in the field. Also, the revealer (phenolphthalein) is environmentally safe. Moreover, the test can be performed by anyone. There is no need for special training. However, determining where tests should be taken should be discussed and planned.

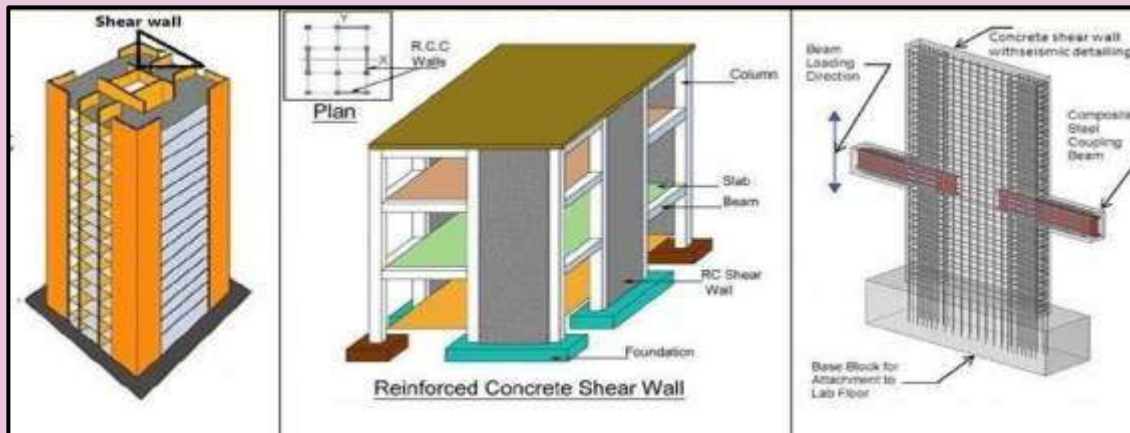
Figure 21: Shear Walls in Buildings

Shear walls must be anchored to the existing foundation to prevent sliding or overturning. This can be achieved by embedding steel dowels or shear bolts into the foundation and floor slabs.

Applications: Recommended for houses and buildings in high seismic zones.

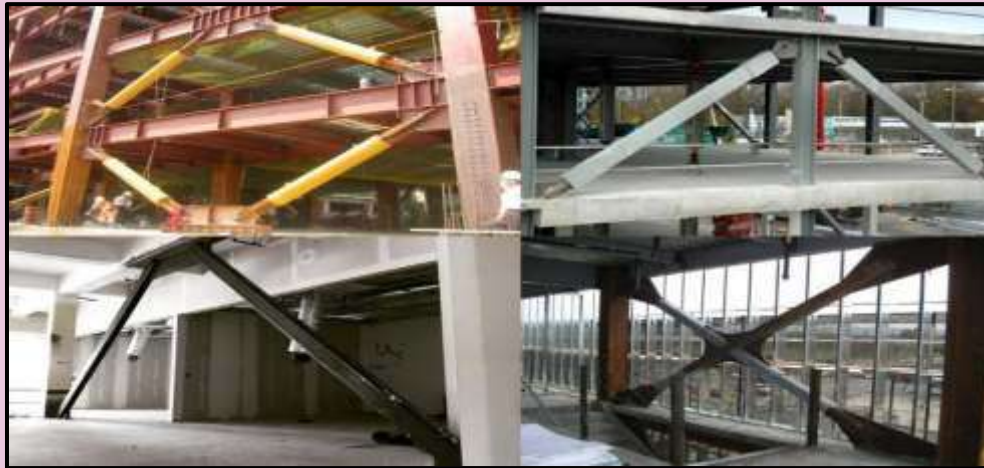
Figure 22: Seismic Bracing in Structures

Use high-strength bolts (Grade 8.8 or Grade 10.9) or welded connections to anchor the braces to the building's structural frame. Ensure that connections are designed to resist tension and compression forces. Bolted & welded connections must follow ASTM specifications.

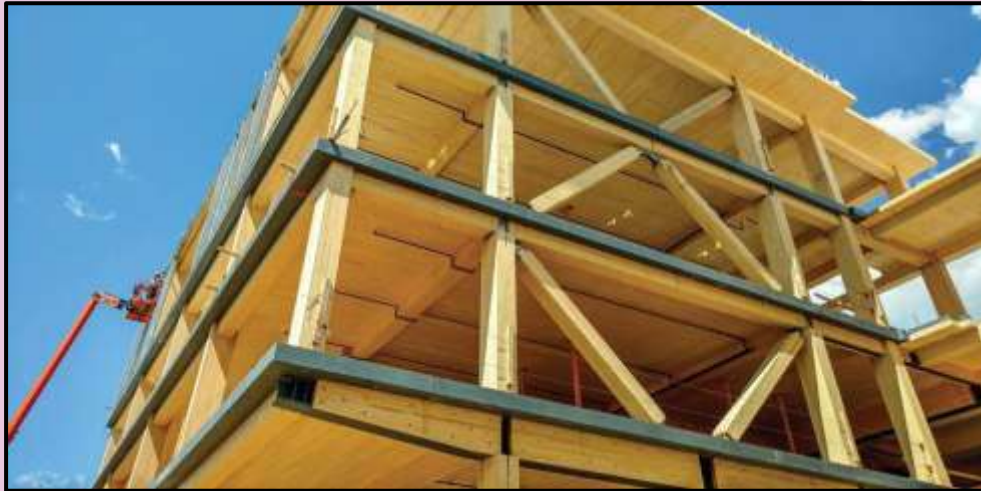
Figure 23: Timber Bracing

- The timber braces should have a minimum cross-sectional size of 100 mm x 150 mm (4" x 6").
- Use steel connectors such as lag bolts, timber screws or bolts to secure timber braces to the building's frame. Ensure the fasteners are capable of transferring shear and axial loads effectively.
- Timber braces are typically configured as diagonal braces between horizontal beams or walls. The braces should be spaced according to seismic design requirements.
- For diagonal timber braces, ensure that the braces are securely attached to the top and bottom of the frame to resist lateral loads effectively.
- Timber braces should be designed with consideration for both axial and shear loads. Follow ANSI/APA PRG 320 for timber structural design and ensure that timber quality meets the necessary strength ratings.

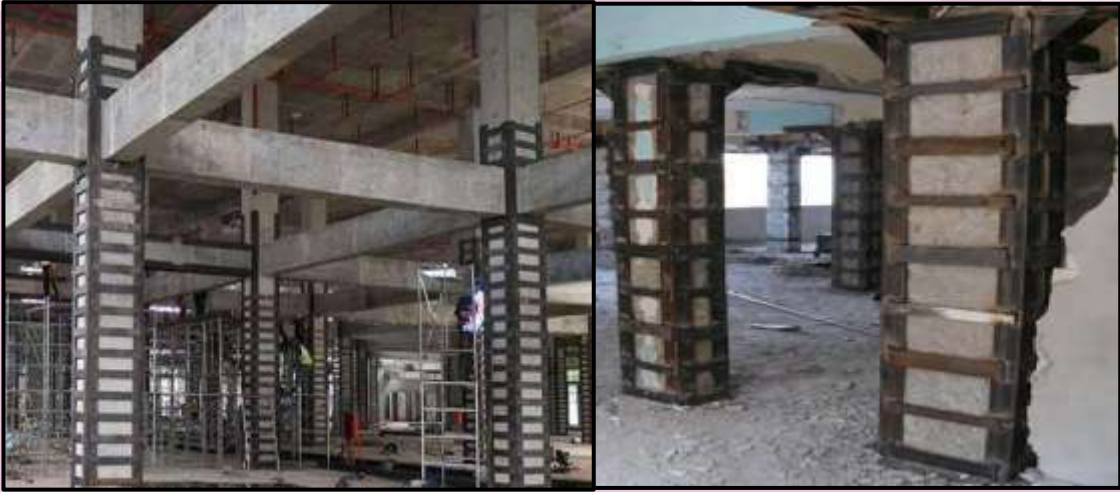
Figure 24: Column Jacketing of Existing Buildings

Applications: Critical for older buildings with weak columns

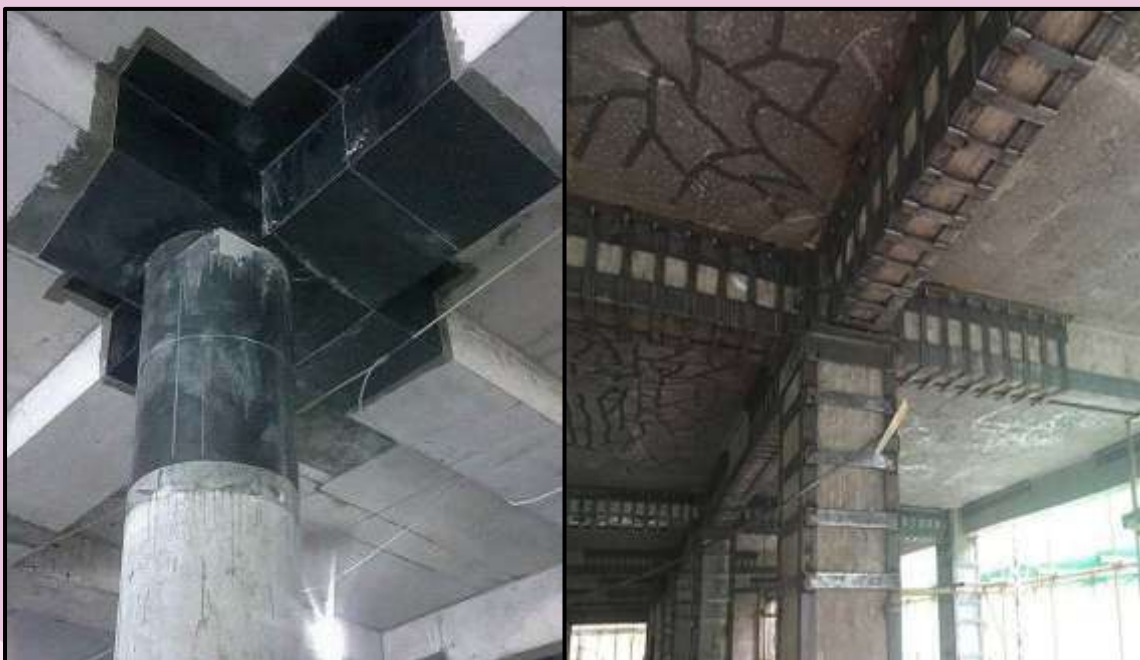
Figure 25: Beam - Column Joint Reinforcement

Applications: Essential for buildings constructed before modern seismic codes.

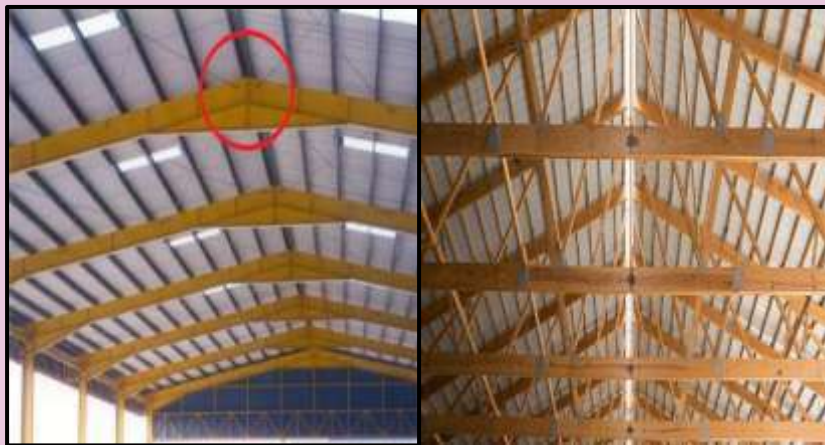
Figure 26: Roof Bracing

Applications: Suitable for both pitched and flat roofs.

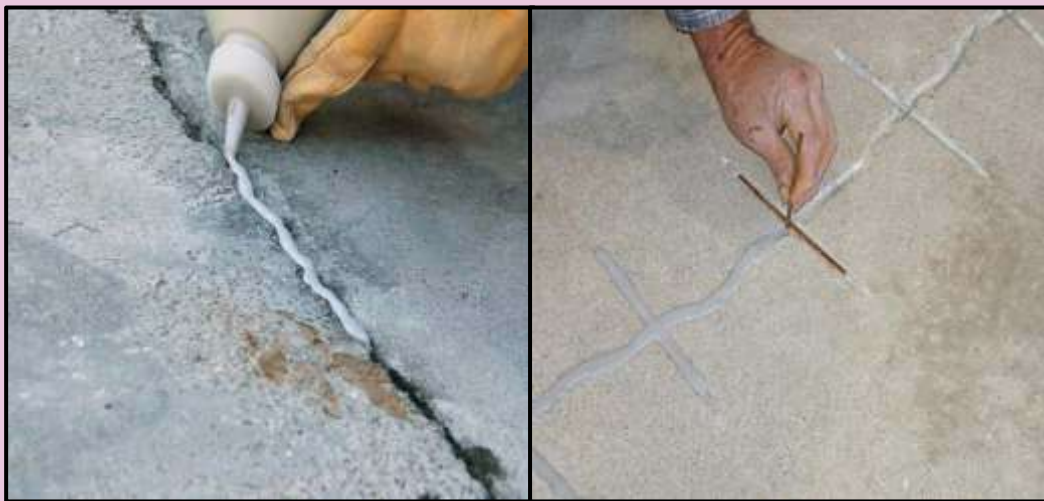
Figure 27: Cracks Filled with Grout

- Remove the plaster near the crack, exposing the cracks in masonry wall. Make the shape of the crack in the V-shape by chiseling out.
- Fix grouting nipples in V-groove on the faces of the wall at spacing 150-200mm c/c.
- Clean the crack with compressed air through nipples to ensure that the fine and loose material inside the cracked masonry has been removed.
- Seal crack on both faces of the wall with cement mortar 1:3 and allow it to gain strength.
- Inject water, starting with the nipple, fixed at a higher level and moved down so that the dust inside the cracks is removed and the masonry is saturated with water.
- Make cement slurry with 1:1 (1-non shrink cement: 1-water) and start injecting from the lowermost nipple till slurry comes out from the next higher nipple and then move to the next higher nipple.
- After injecting grout through all nipples, re-plaster the surface.

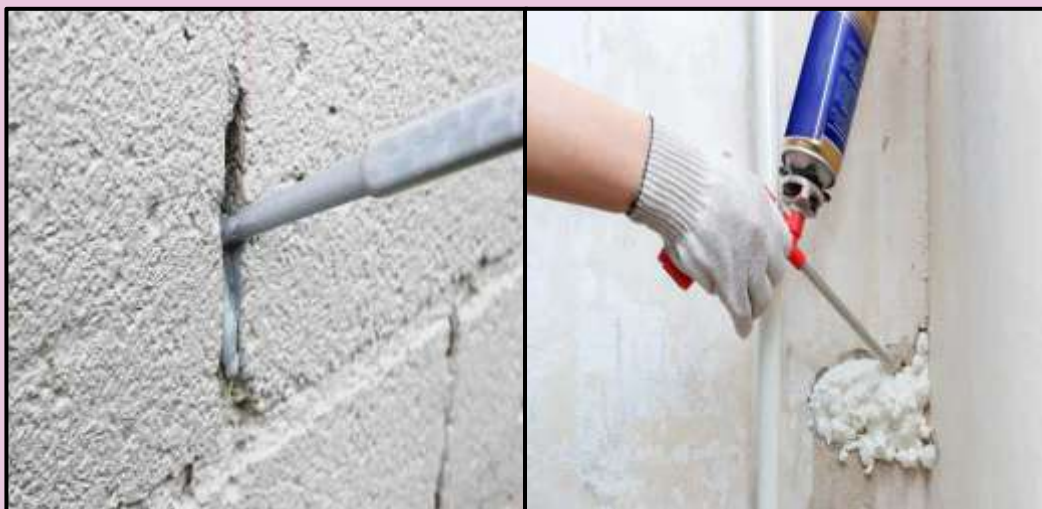
Figure 28: Grouting of Major Cracks in Walls and Columns

- Clean the crack with compressed air to make a V-groove.
- Fix grouting nipples in V-groove on both wall sides at 150-200mm c/c spacing.
- Clean the crack with the compressed air through nipples to ensure that the fine and loose material inside the cracked masonry has been removed.
- Seal the crack on both faces of the wall with polyester putty or cement mortar and allow strength to be gained.
- Inject water starting with nipples fixed at a higher level and moving down so that dust inside the crack is removed & masonry is saturated with water.
- Make cement slurry with 1:2: water (1-non shrinking cement: 2 fine sands: just enough water) and start injecting from the lowermost nipple till the slurry comes out from the next higher nipple & then move to the next higher nipple.
- After injecting grout through all nipples, re-plaster the surface.

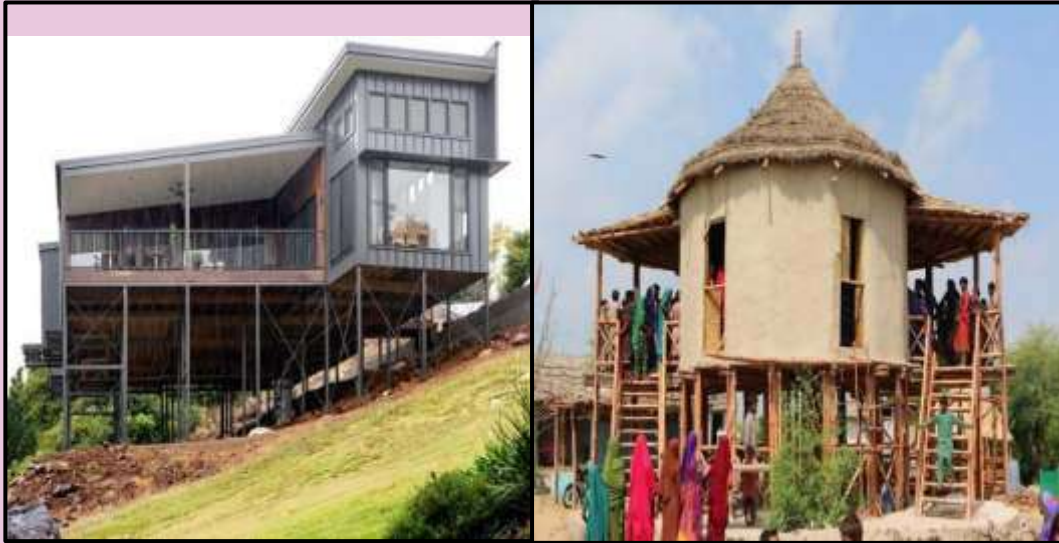
Figure 29: Elevated Houses using Stilts

Applications: Suitable for flood-prone lowlands.

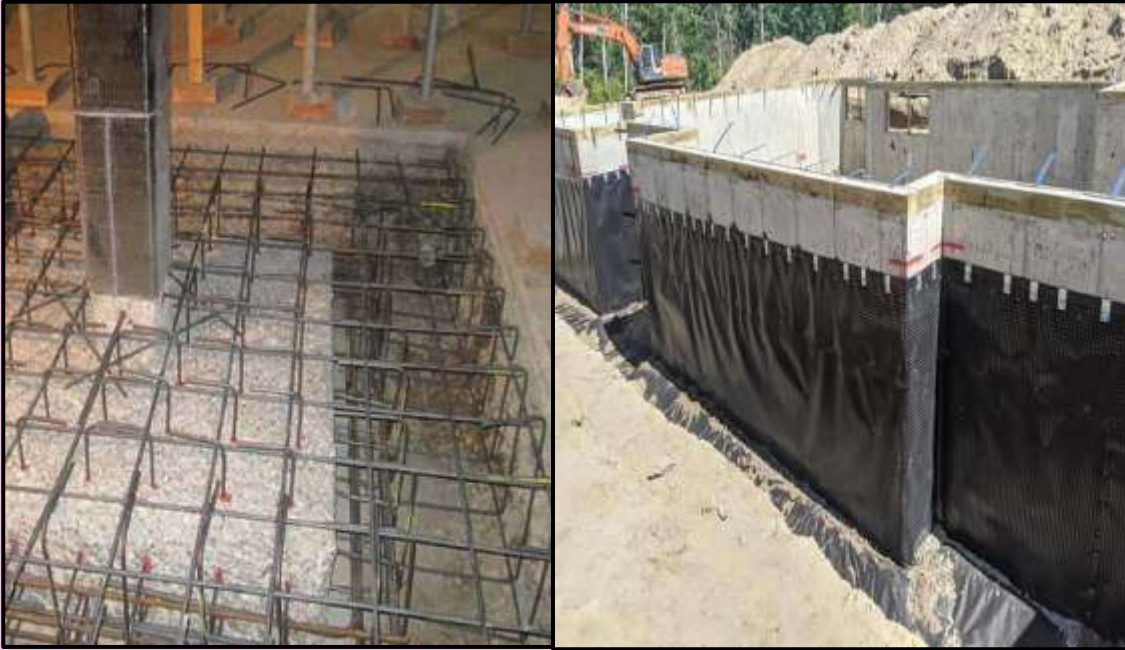
Figure 32: Reinforcement of Foundation

Applications: Necessary for houses near rivers or coastal areas.

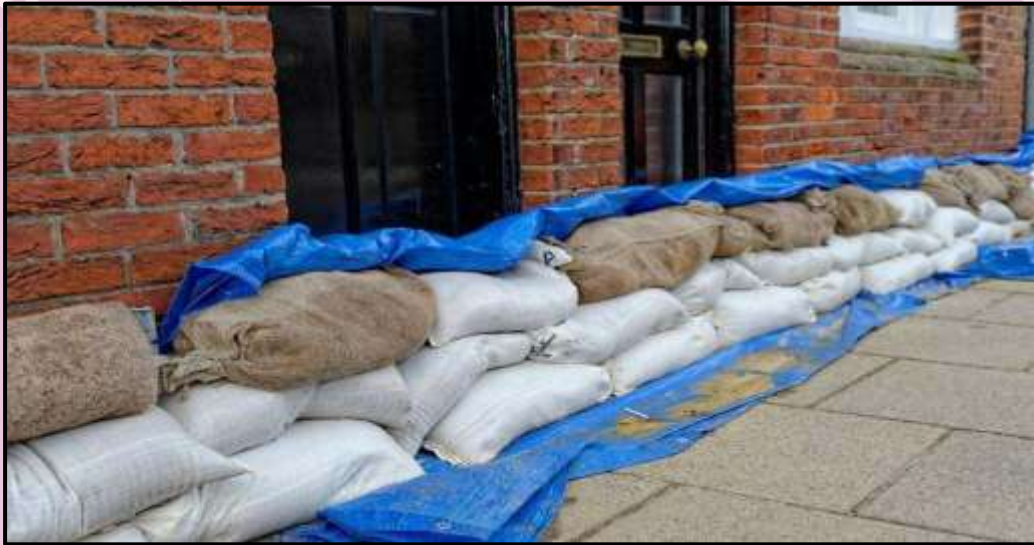
Figure 33: Sandbags Installed Around the Perimeter of House

Sand: Coarse sand is recommended as it compacts easily and resists erosion.
